RE: LYNNWOOD RECREATION CENTER NATATORIUM

Location of Loss	: 18900 44 <sup>th</sup> Avenue West, Lynnwood, Washington
Date of Loss	: January 1, 2011 (Reported)
Affiliated FM Insurance Company Claim ID	: 425958
Thornton Tomasetti No.	: G13106.00

**APPENDIX A: PHOTO REPORT**

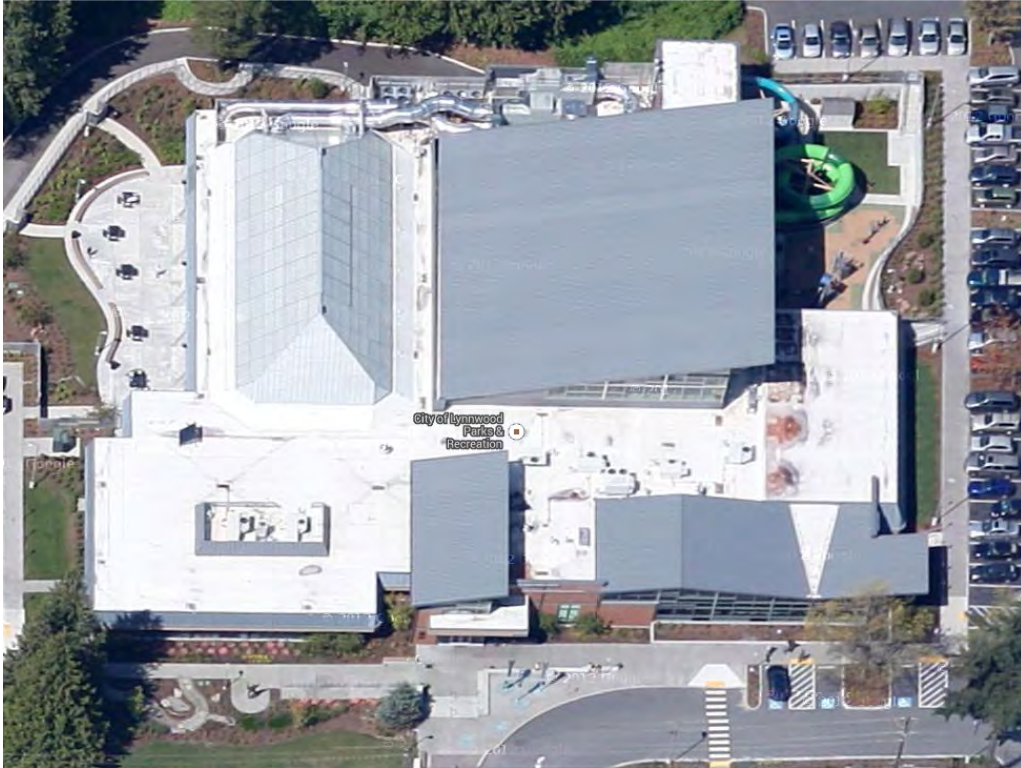
Photo 1: Aerial view of Recreation Center, looking west

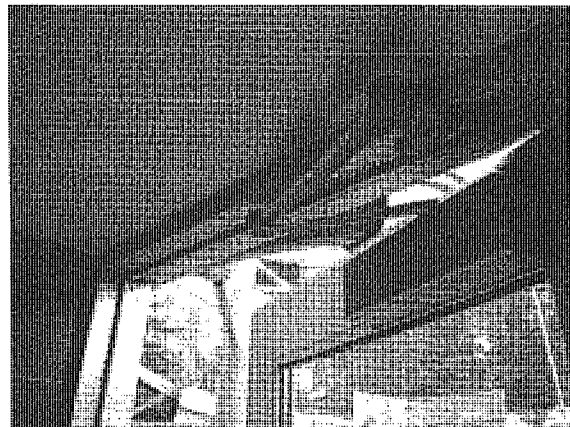
Figure 6. Condensation on exterior door frame

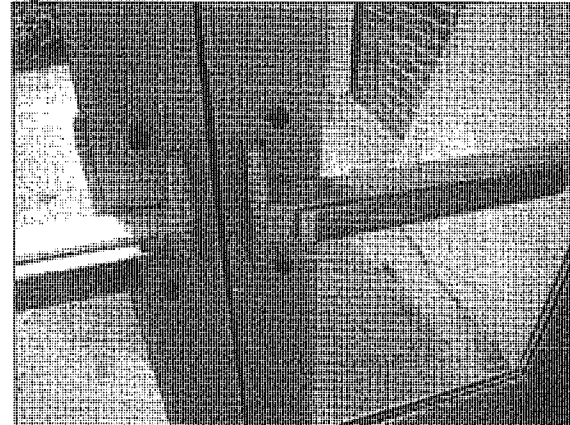
Figure 8. Corrosion on door hardware

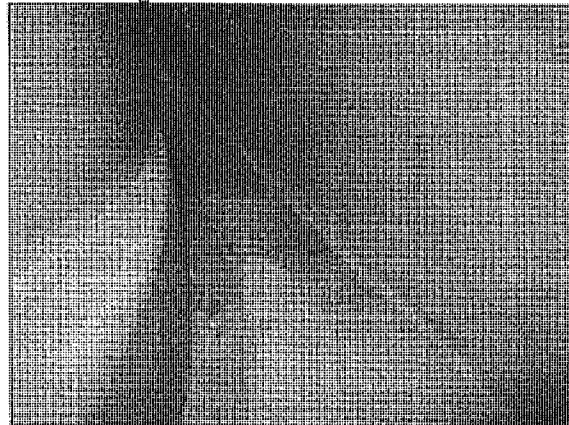
Figure 53. Maintenance staff added sealant at base of tile wall next to tube slide in hopes of solving the unknown moisture damage in the boiler room below

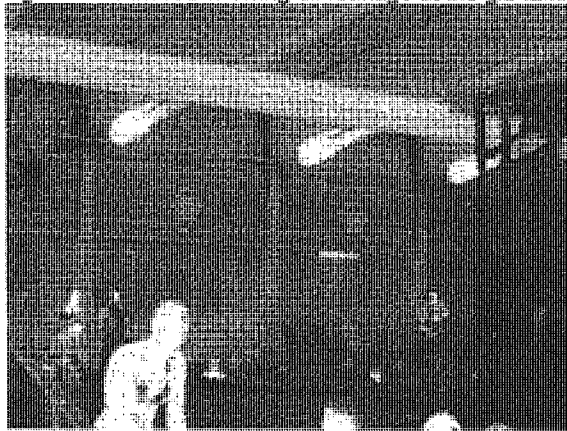
Figure 65. Infrared showing air leakage at the glu-lam/wall interface

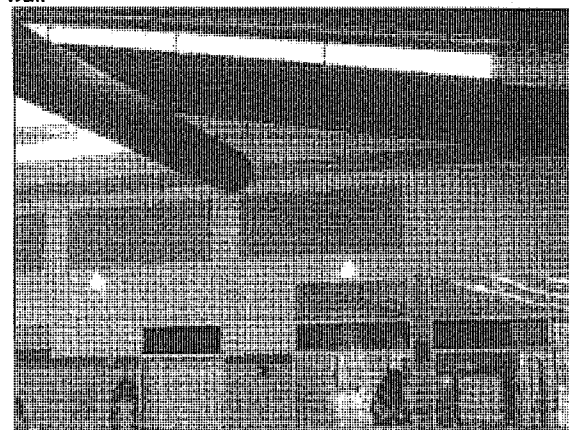
Figure 78. Infrared showing air leakage at junction box cover and possible moisture loading in wall

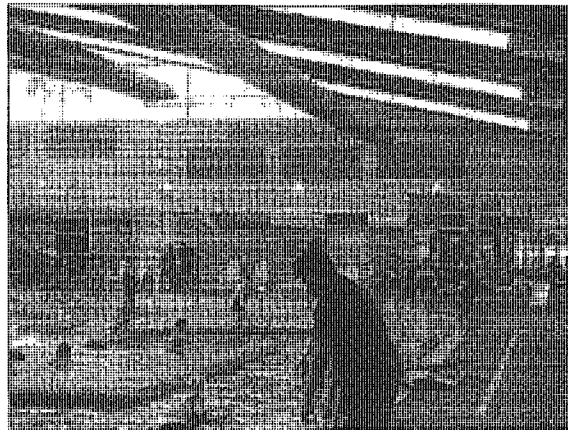
Figure 94. Infrared showing air leakage at wall to ceiling transition

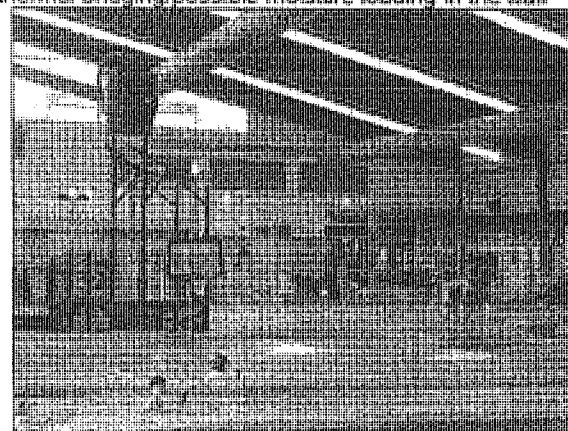
Figure 96. Infrared showing air leakage at windows and wall to ceiling transition as well as thermal bridging in the wall

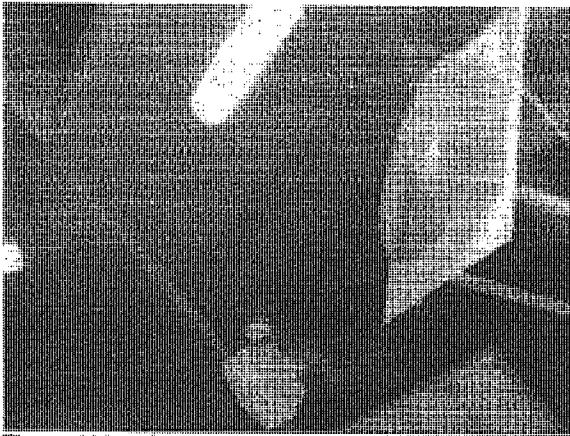
Figure 103. Infrared image showing thermal bridging

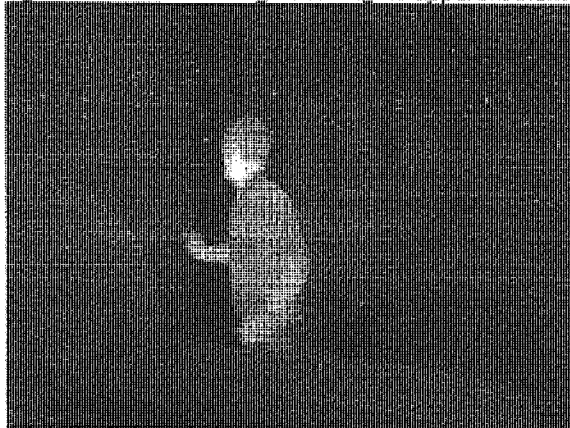
Figure 107. Infrared image showing thermal bridging in slide loading area

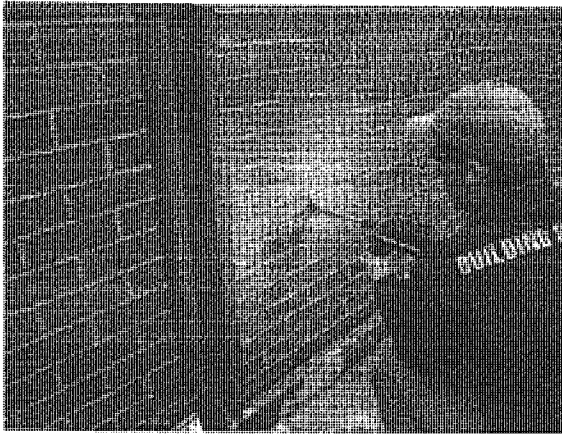
Figure 3. Invasive opening created

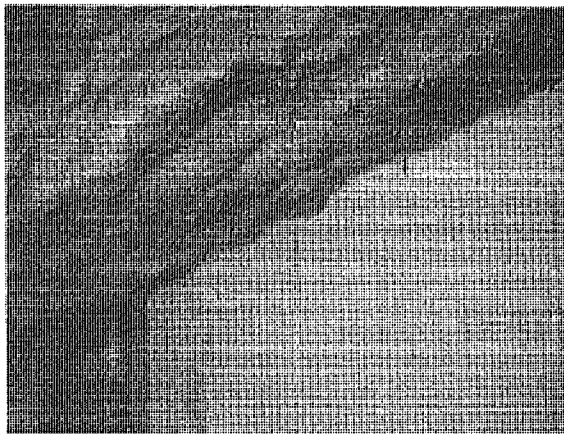
Figure 23. Saturated batt insulation and corrosion occurring on fasteners that penetrate into the framed cavity

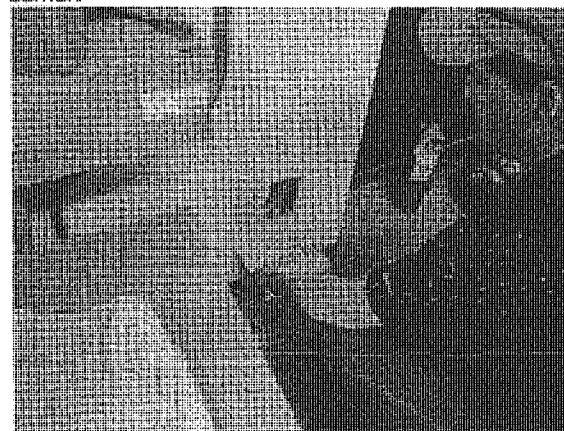
Figure 27. Opening on second floor in boiler room

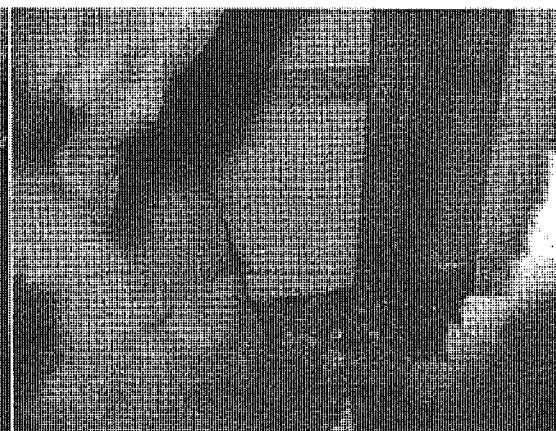
Figure 28. Insulation moist to the touch and evidence of moisture in framed cavity
